**Consulting Arborist's Report
September 15, 2022**

Tree Assessment Report

14005 Live Oak, Irwindale

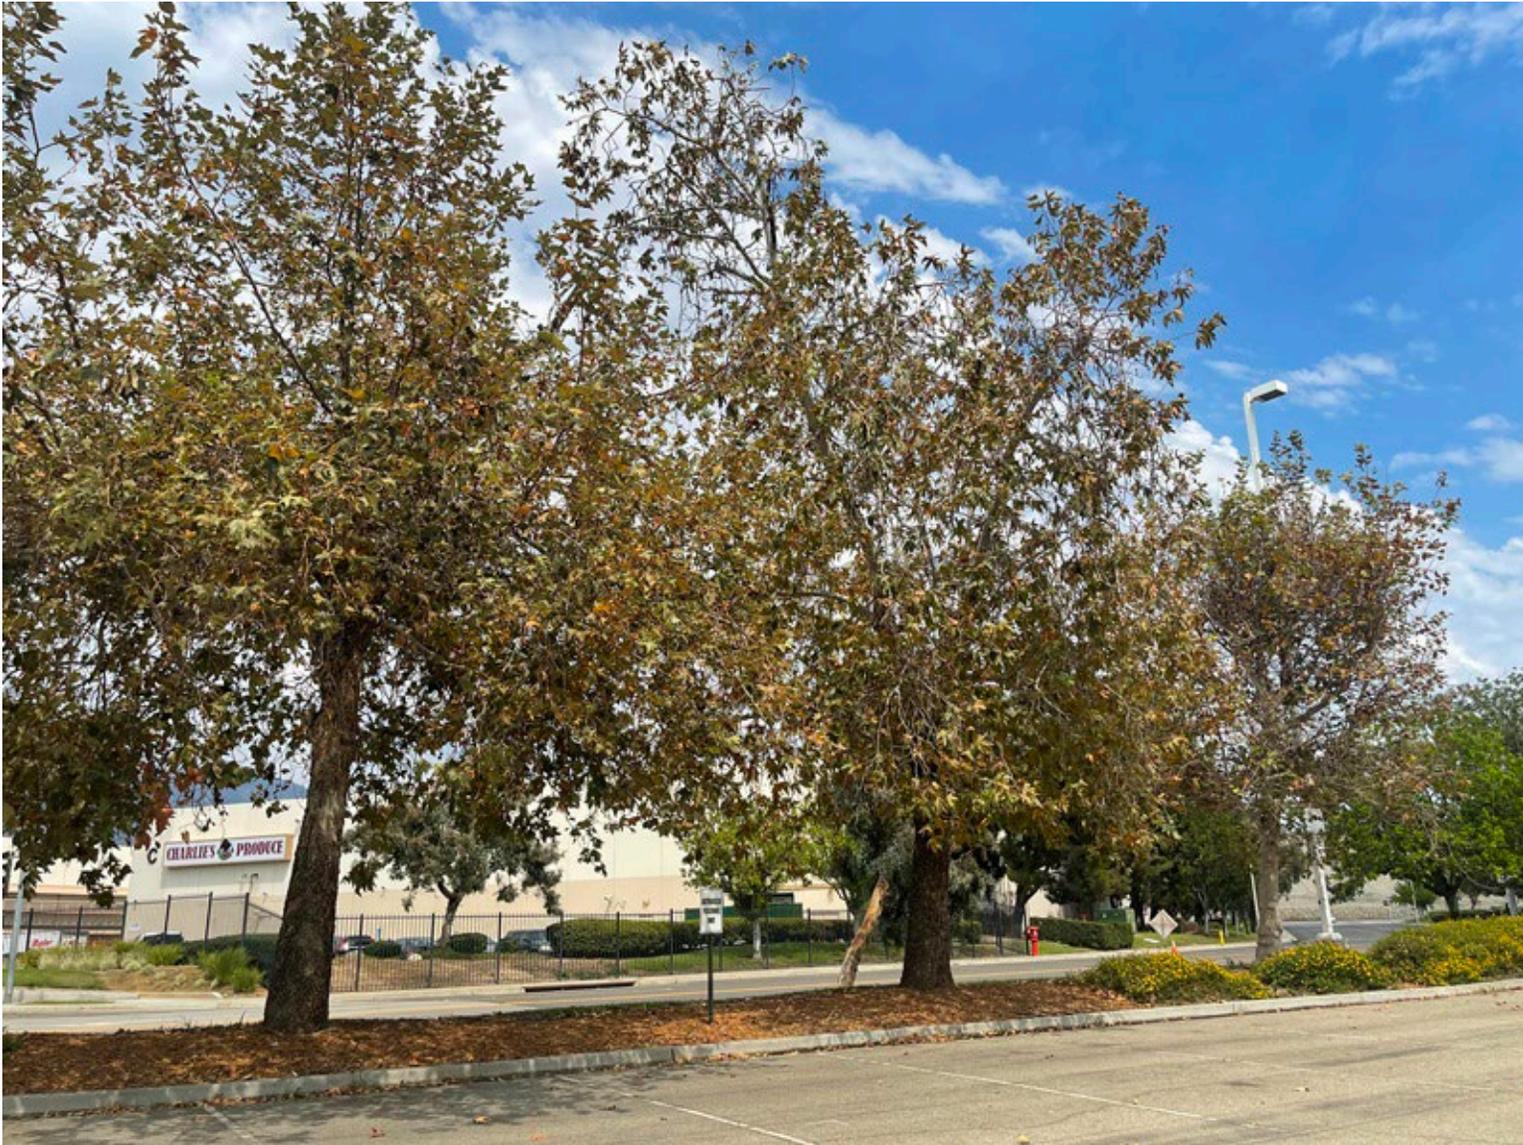
Sycamores #3, 4 and 6 Tree #3 were probably topped years ago.

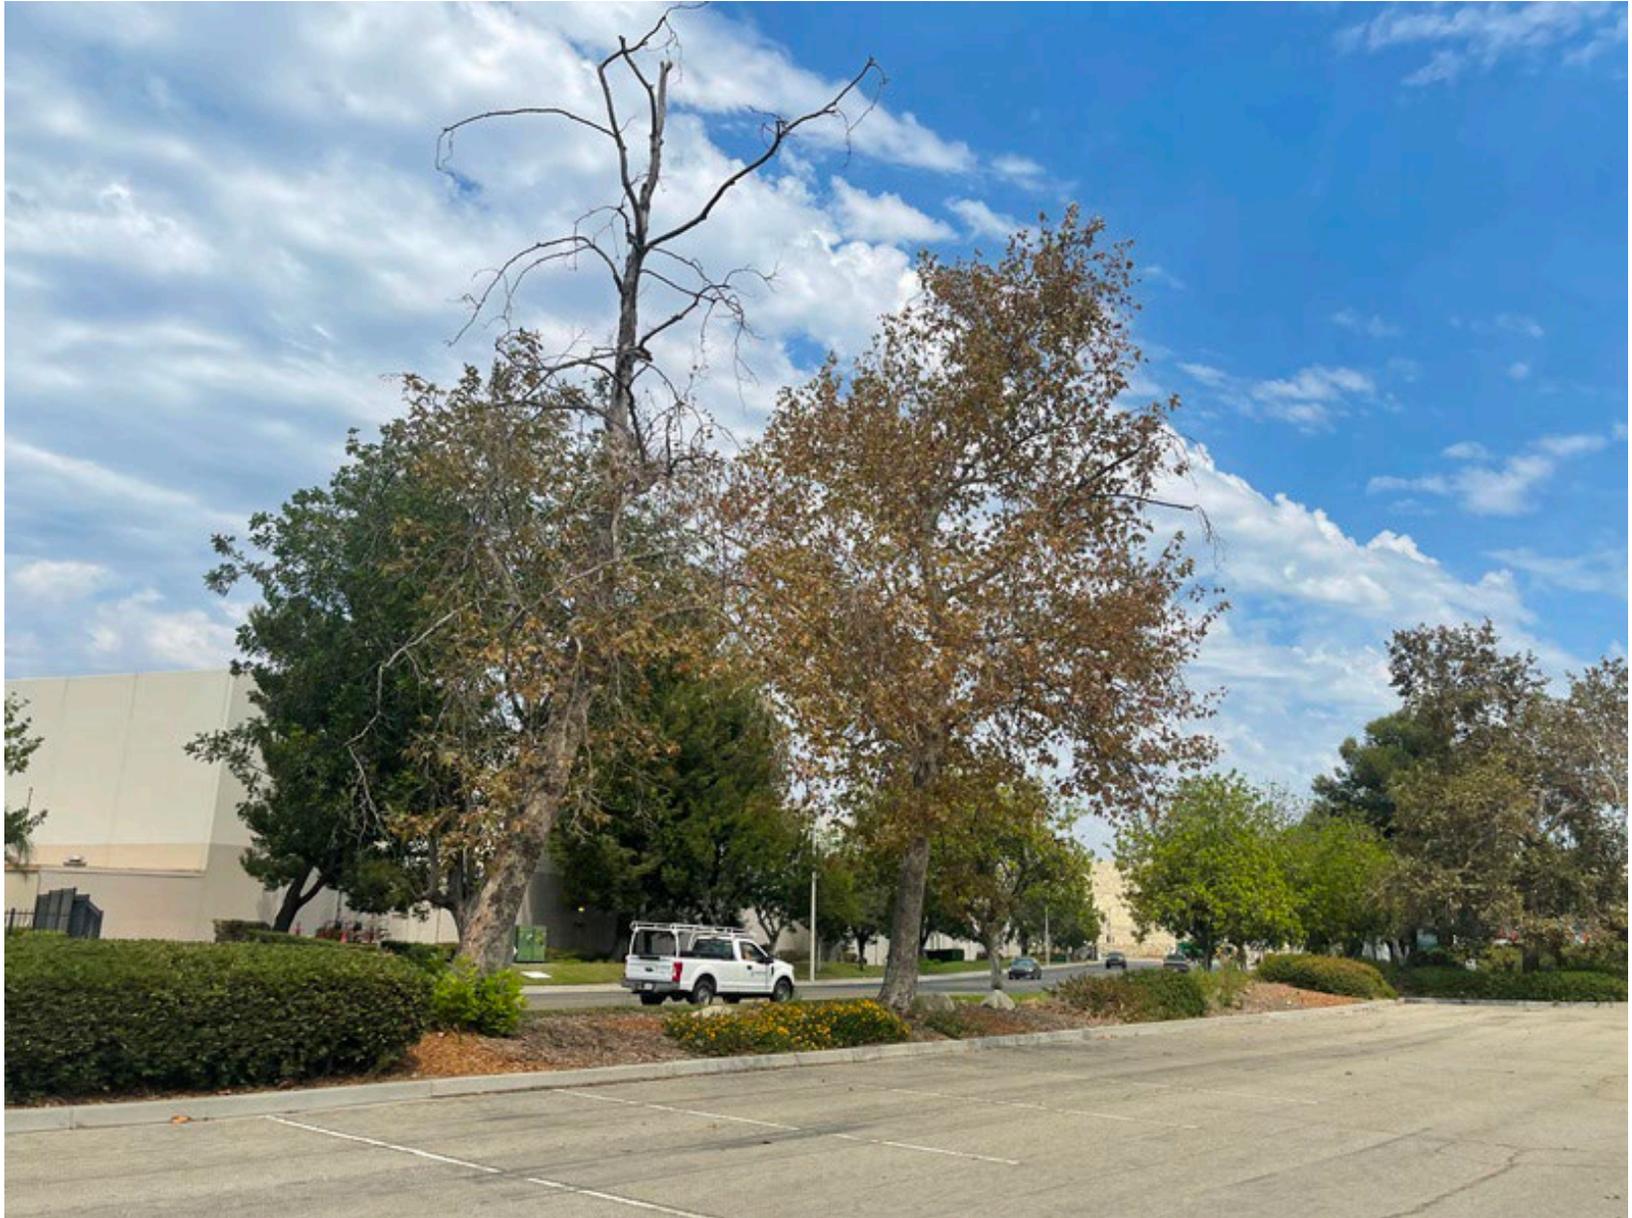
Sycamores #9 and 10 – note dead top.

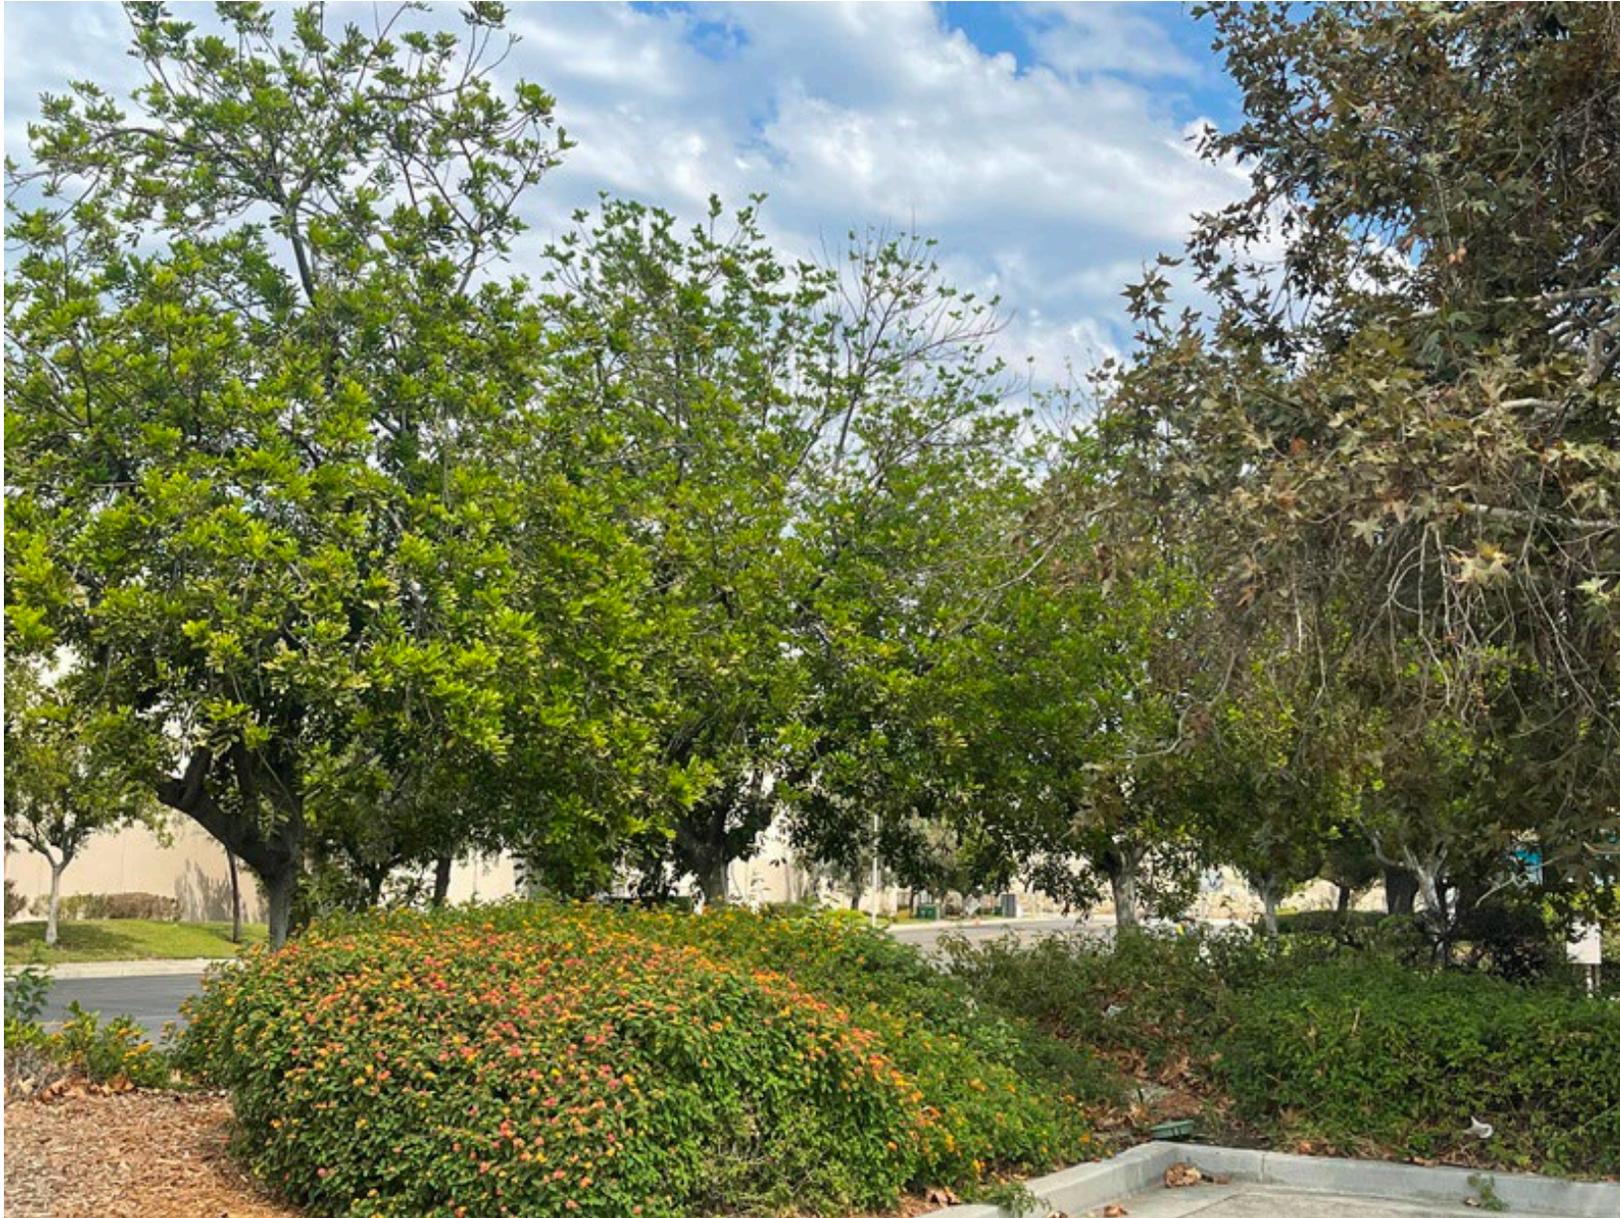
Carrotwoods #12 to 14 – note crowding.

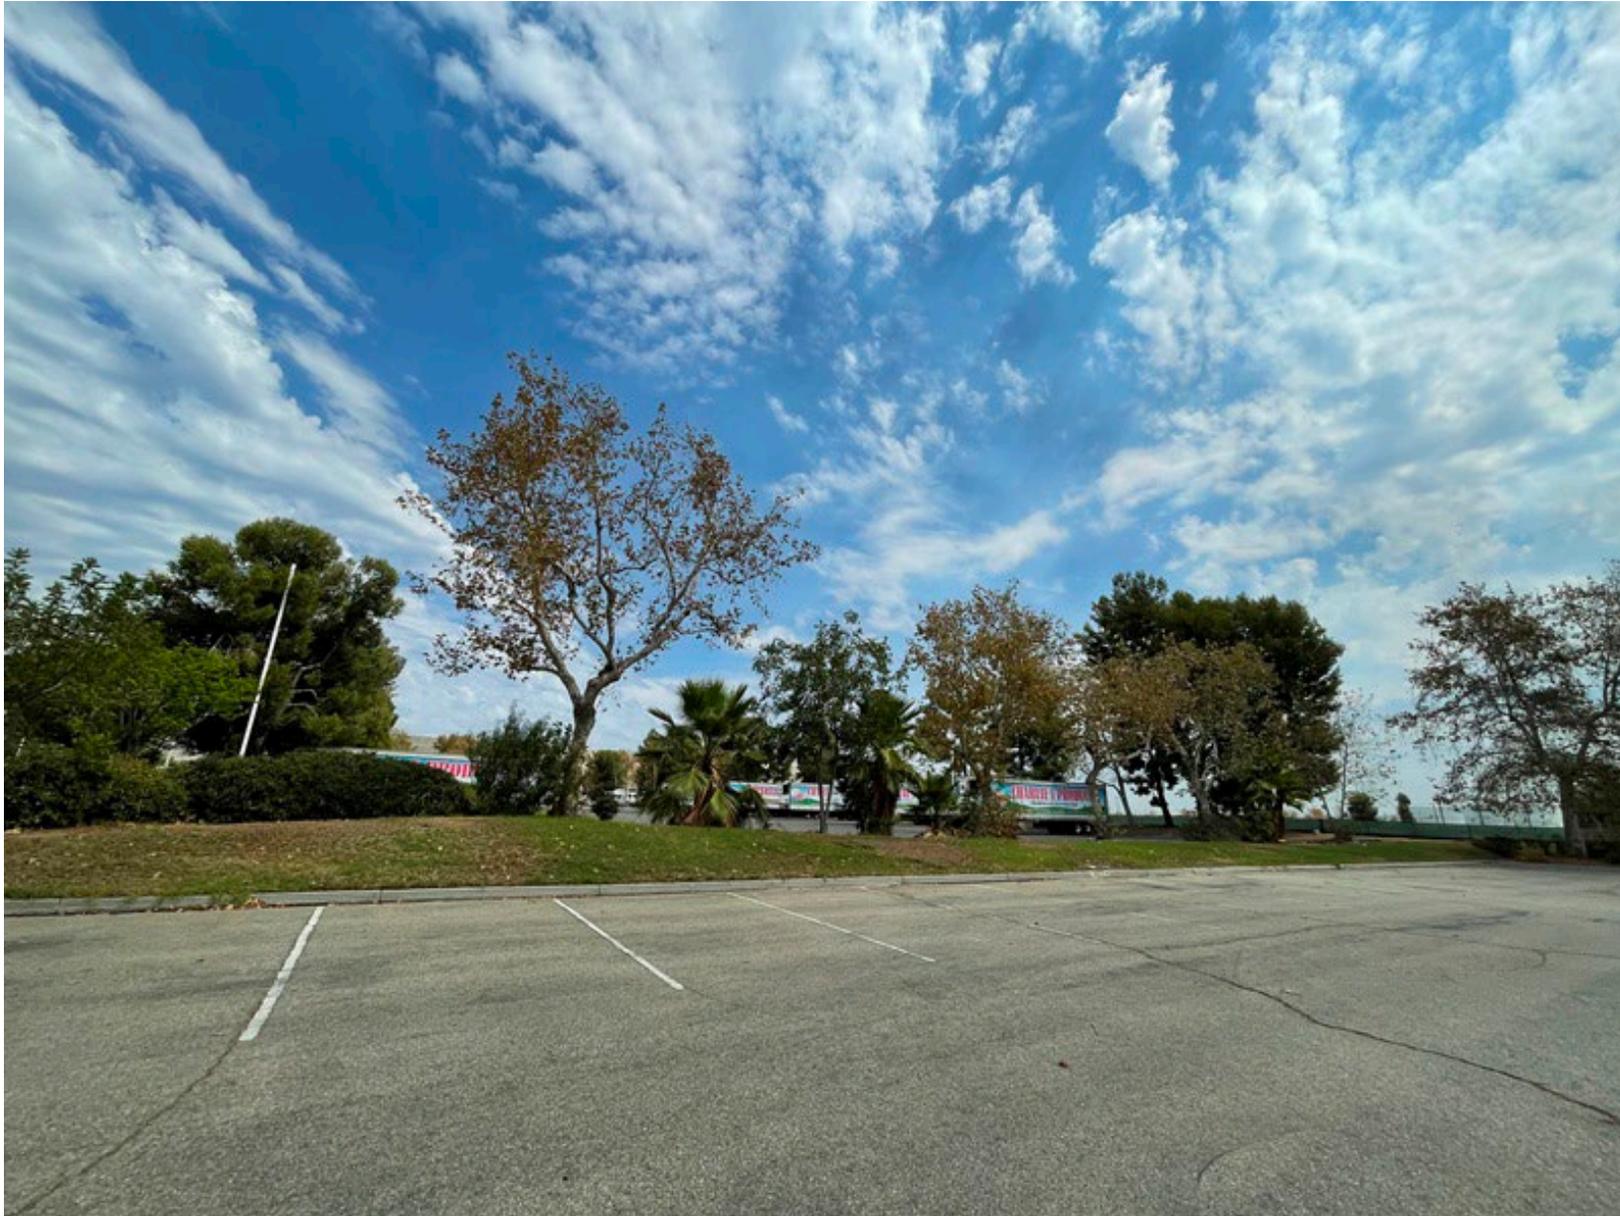
It is also important to keep the neighbor's trees healthy and stable. The trees #16 to 21 may be on the property line, or they may be on the neighbor's property. In either case the trees may not belong to this property. The radius listed in the clearance radius column only covers the stability issue.

Trees #16 to 21 may belong to the property above.

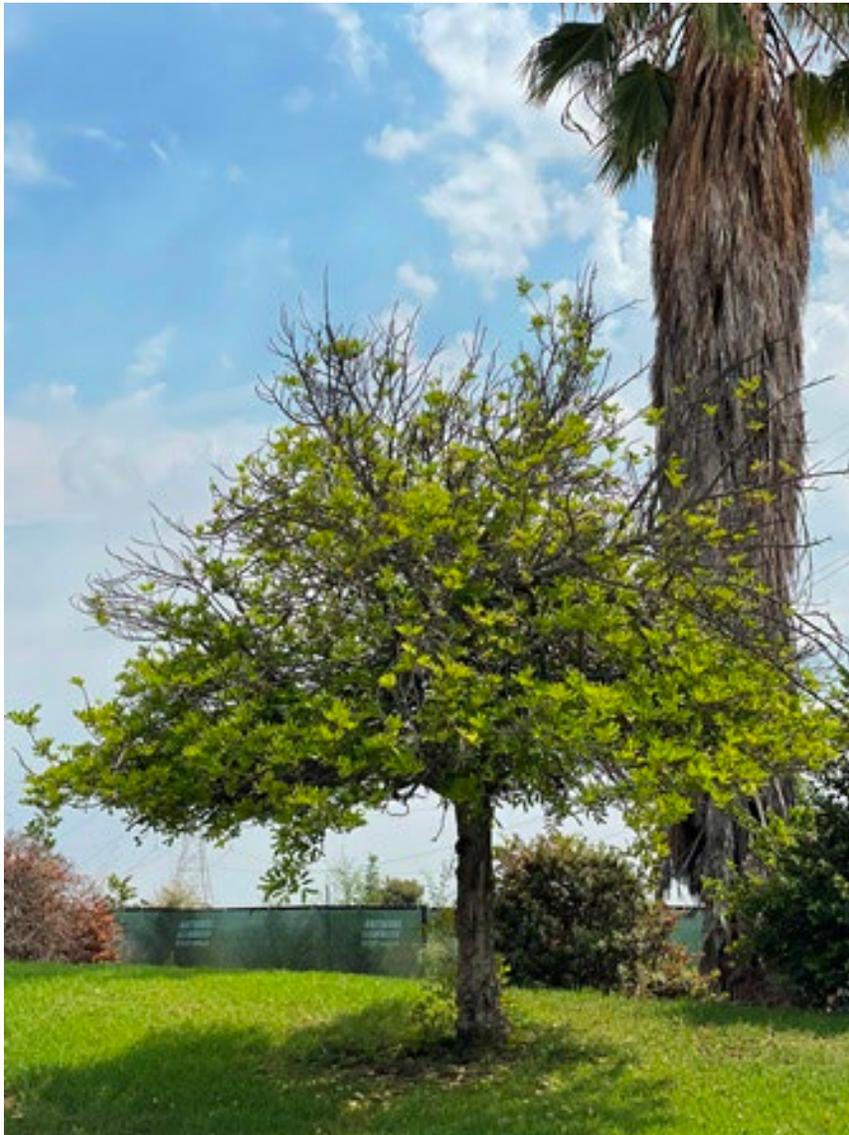
Carrotwood #23 – note dieback and pale color.

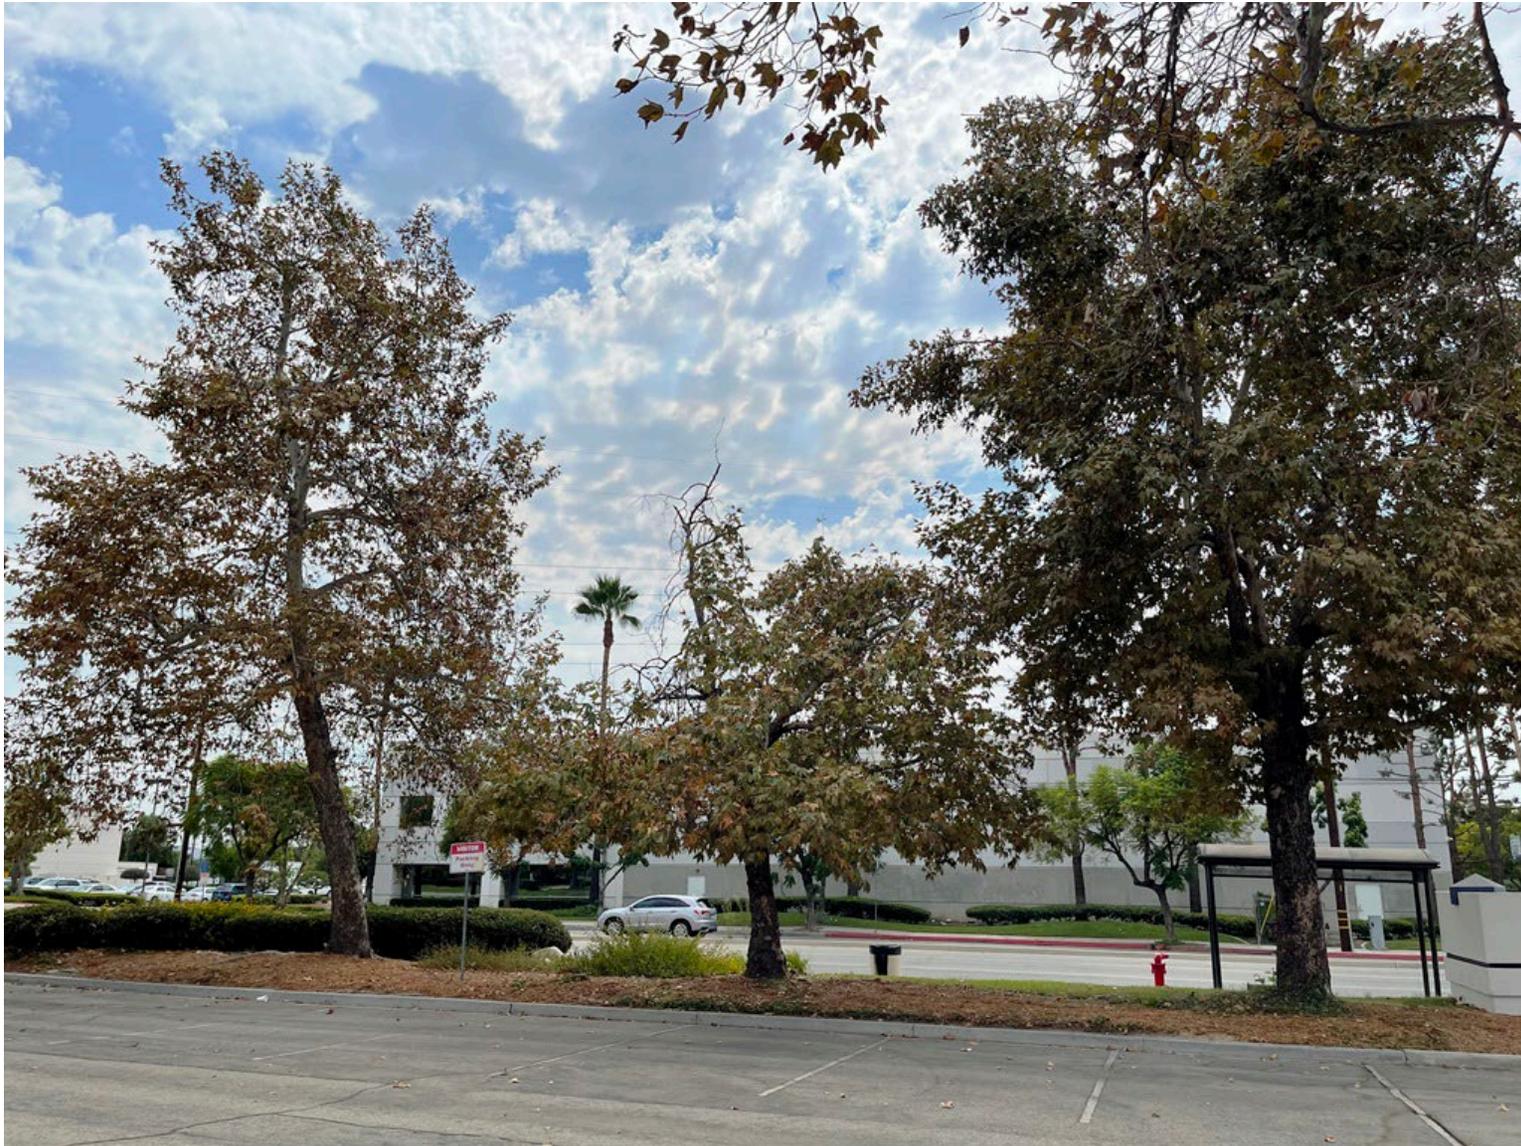
Sycamores 54 to 46 – note dead top

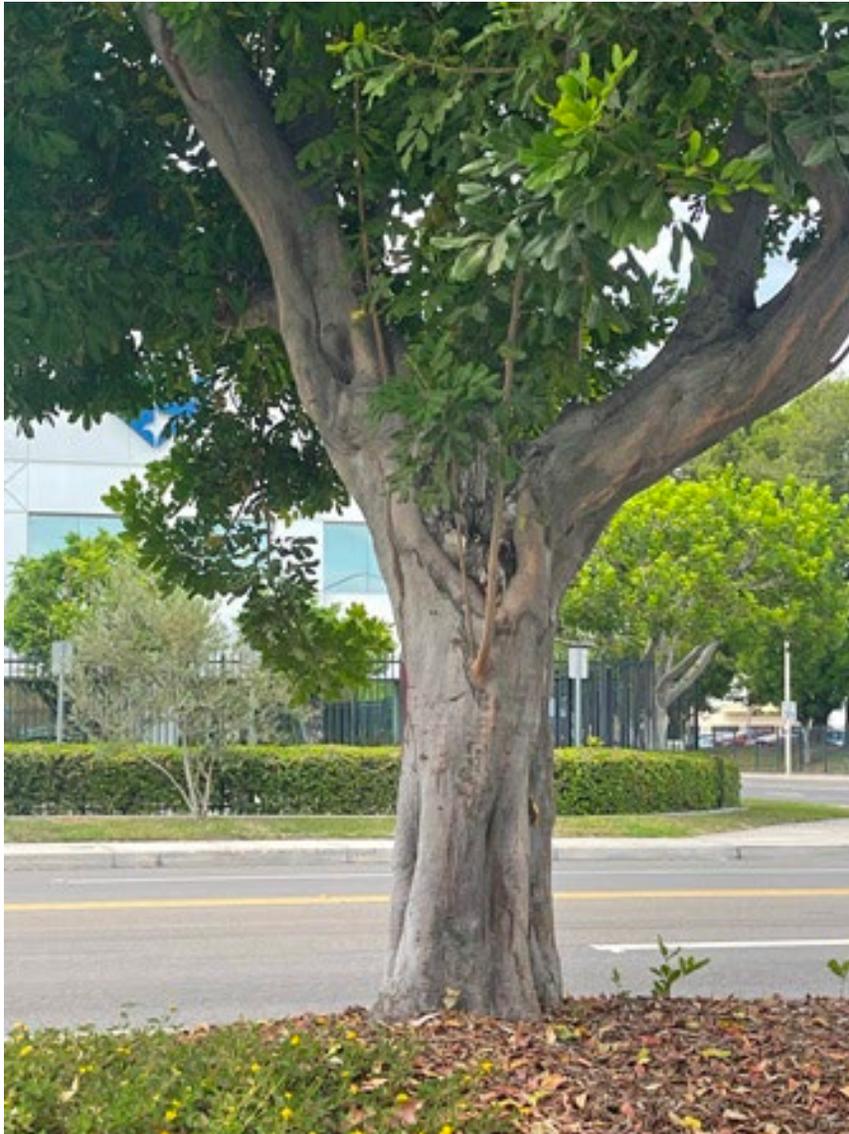
Carrotwood #1 – note large cavity where a limb tore out.

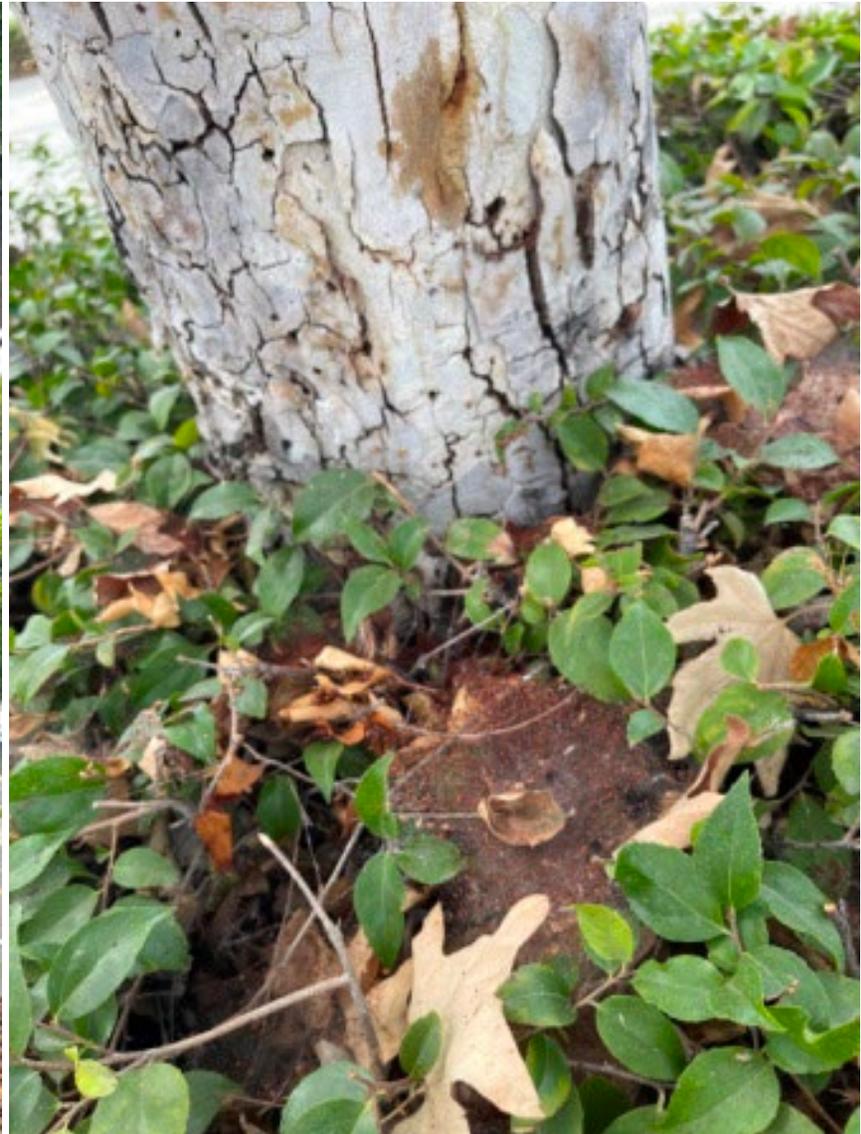
The pest or disease issues are factors in the above considerations, The sycamores show minor signs of flathead borers and a few had symptoms of the invasive shot-hole borer. The shot-hole borer spreads three fungal diseases that increase decay and limb drop. Since the majority of trees are sycamores, which are favorite food for these insects, any new planting should be with other species.

Flat head borers signs. Holes in the bark and fine saw dust in web

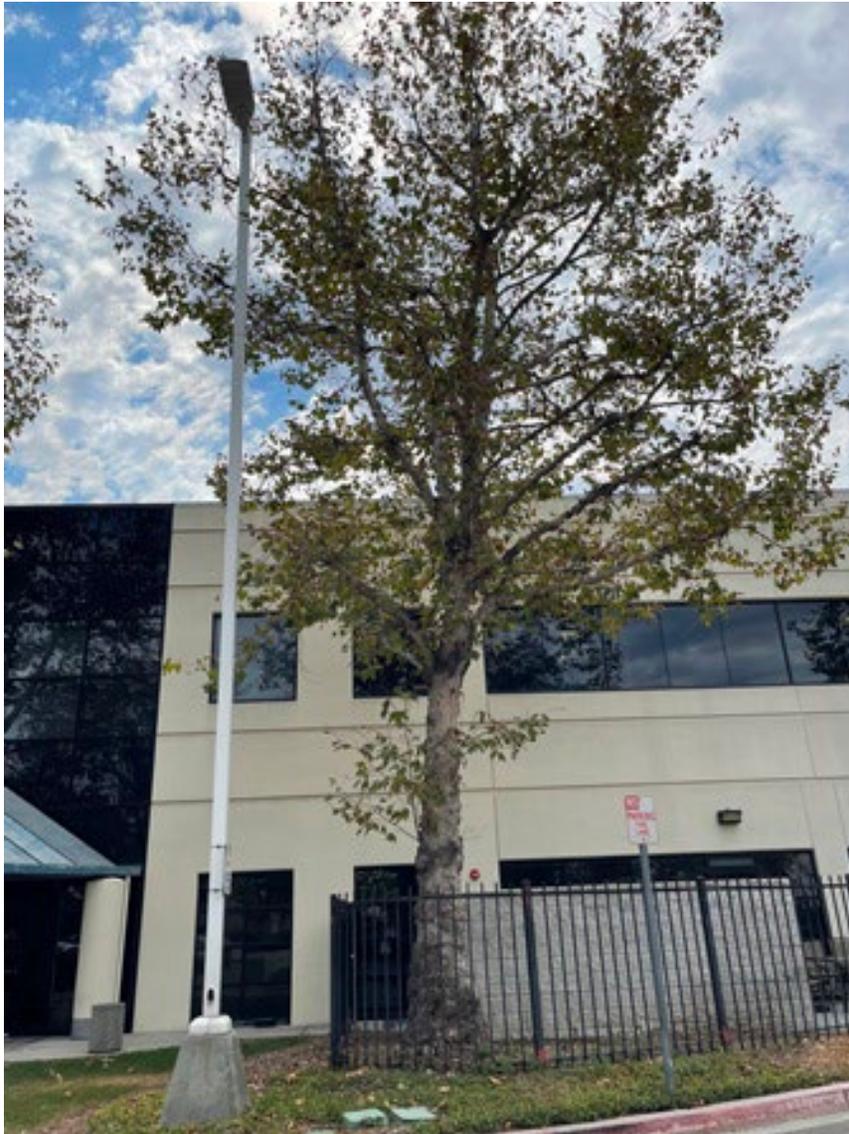
Sycamore #40 – note past topping

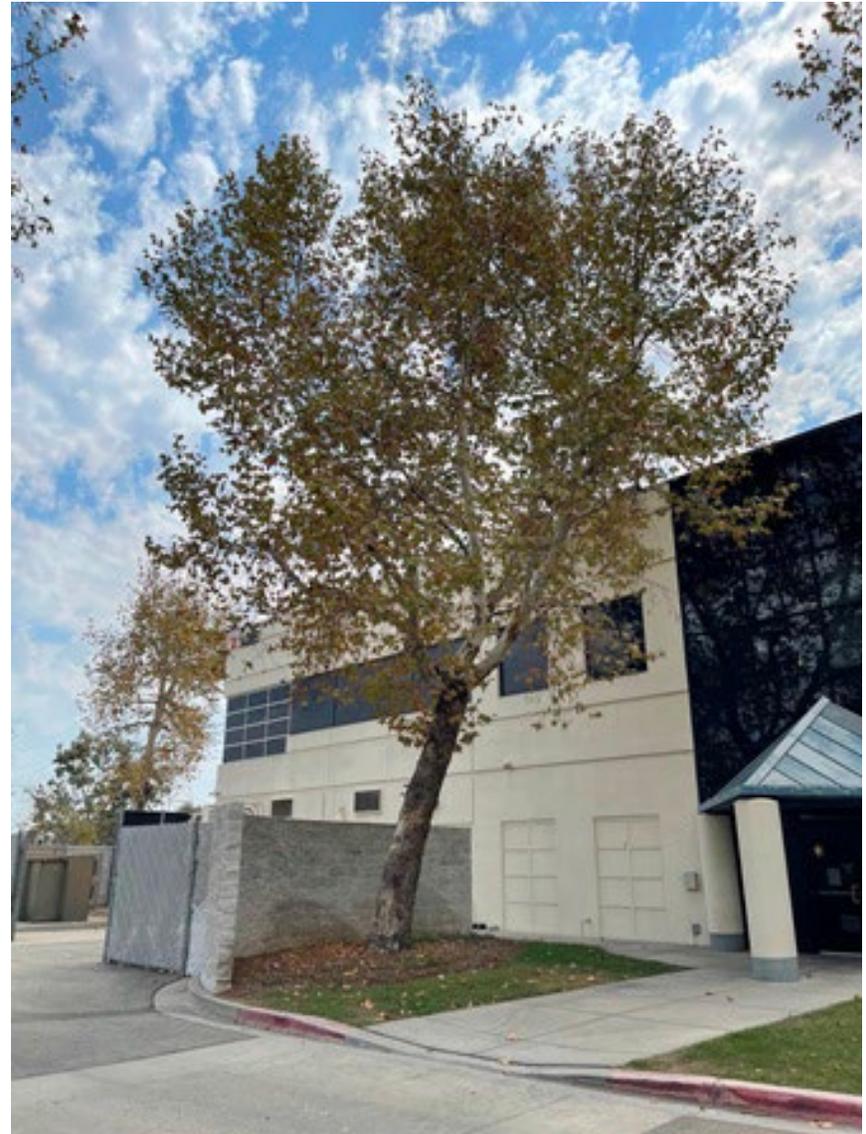
Sycamore #41 - note past topping

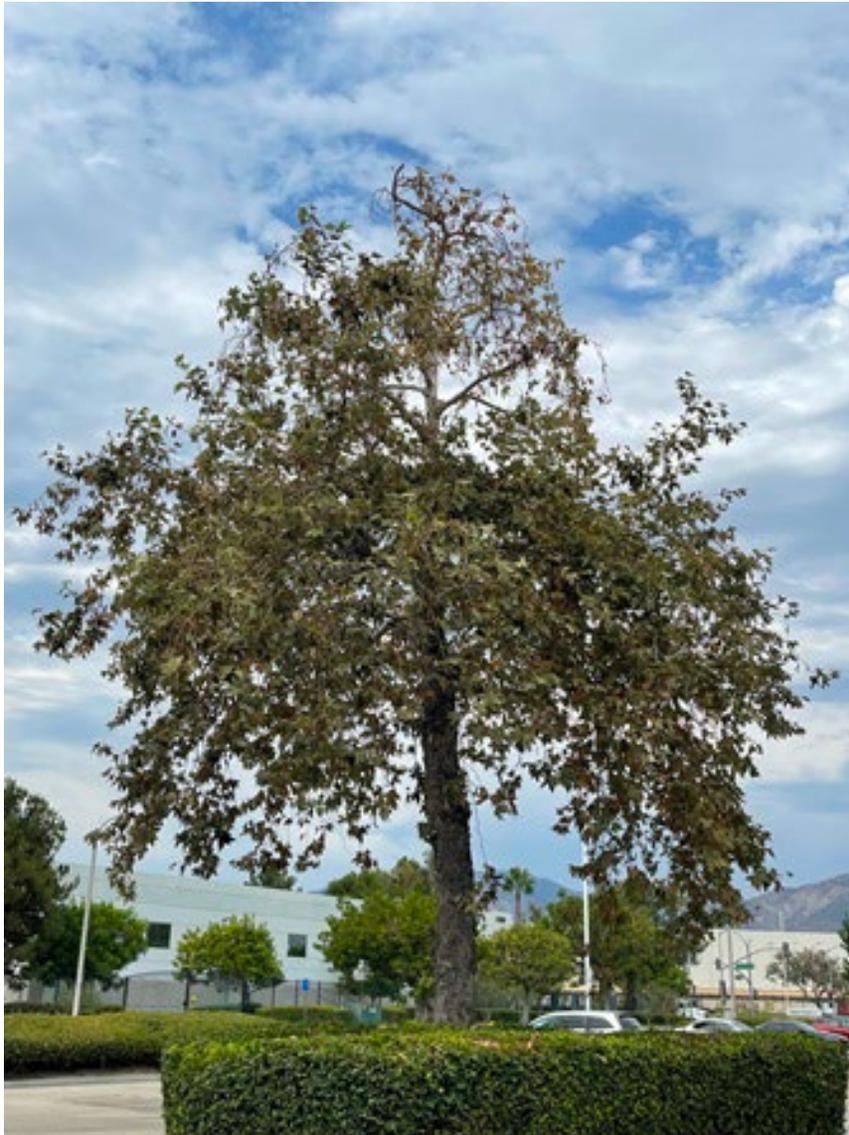
Sycamore #37 – note dieback in the top

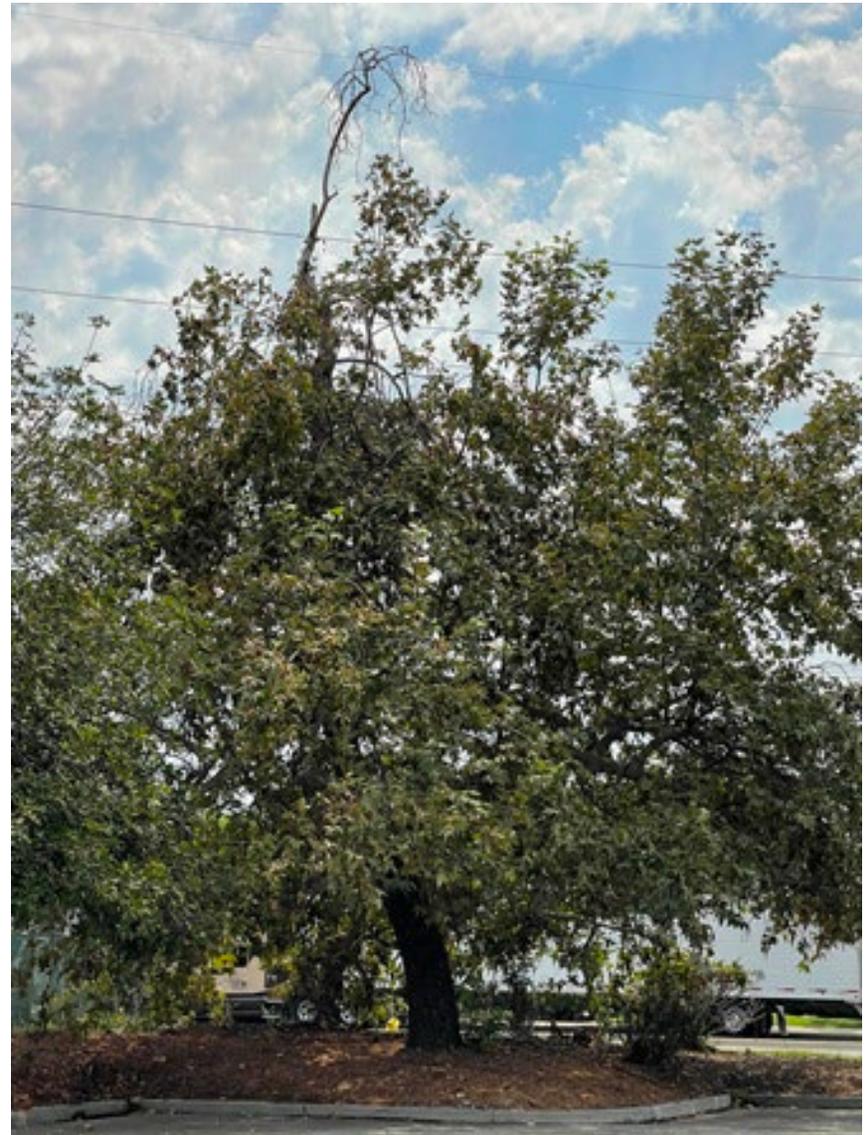
Sycamore #53 – note dead top
