**Consulting Arborist's Report
September 15, 2022**

Tree Assessment Report

14005 Live Oak, Irwindale

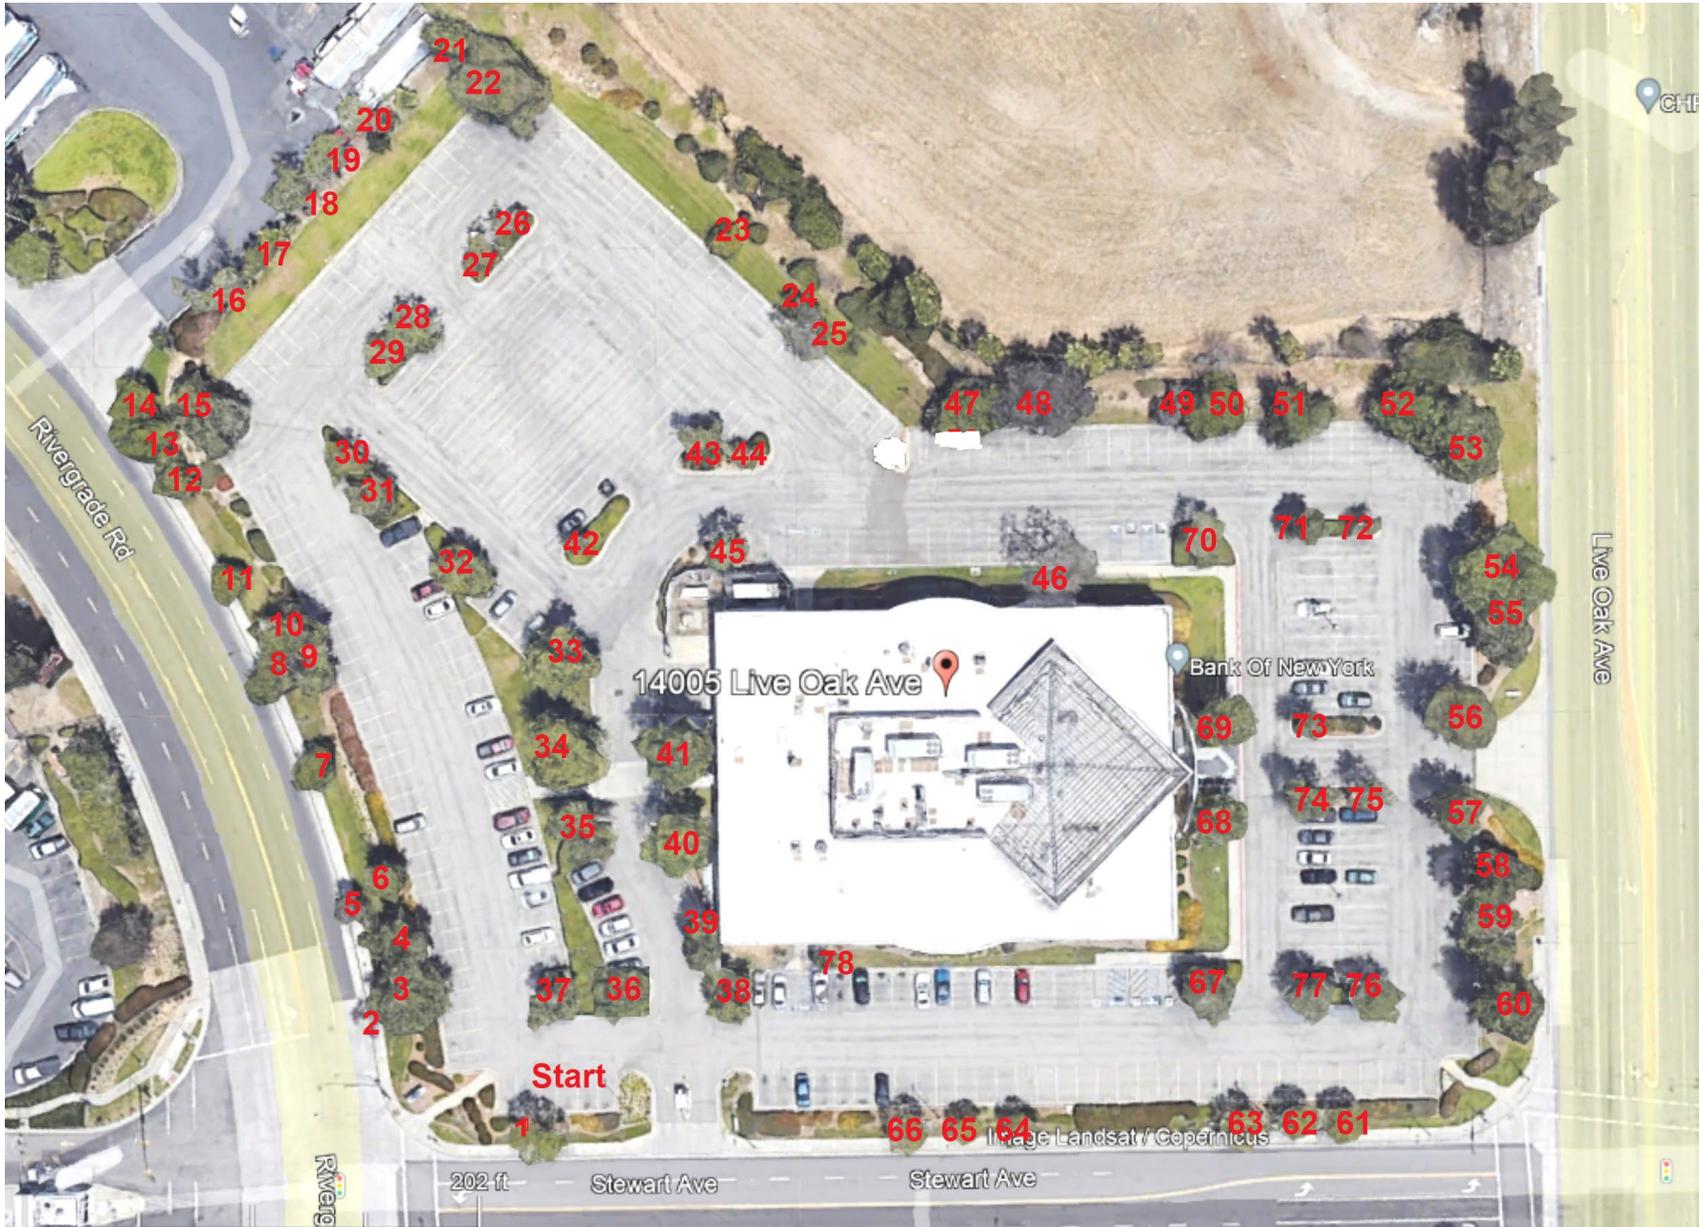
Study Area & Tree Map

There are no trees protected by City ordinance and no City ordinance affecting these trees. The enclosed tree location map shows the approximate location of the 78 trees in the designated area. The overall site has a minor slope from north to south. The enclosed tree location map is used as a base map to give approximate tree locations (not surveyed by this consultant).
